Sidem Nr.	Application	Reference nr.
Stabiliser link	3360	Ford	1 361 653
		Seat	7M0 411 317 C
		Volkswagen	7M3 411 317 C

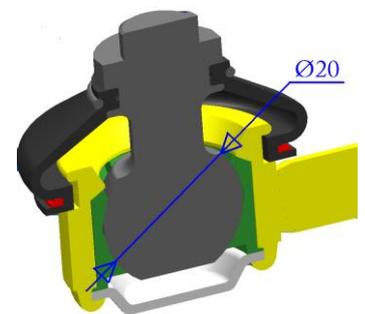
Original:

- Play on Ball joint

- Due to its location, this stabilizer link is exposed to all kind of external influences. When a dustcover is damaged or is not fitting perfectly, water and dirt finds its way into the joint. This causes oxidization of the ball pin, which leads to wear of the plastic cup.
- The cars who use this stabilizer link are big and heavy cars. Their weight, height, wind load ... cause high surface pressure on the ball head and makes them wear faster.
