**Track Control arm
BMW (E46)**

Sidem Nr.
21674 R
21675 R

Reference nr.
31 12 6 777 851 R
31 12 6 777 852 R

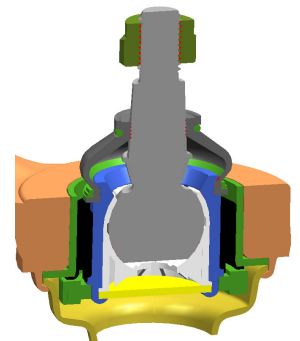
Original:

- Early wear of rubber bedding Ball Joint.
- Play on ball joint.
- Early wear Silent block

- Weak connection by rubber between inner and outer bushing.
- Damaged dustcover.
- Wrong method of mounting silent block.
