Sidem Nr.	Reference nr.
Audi Tie rod end	37630	4F0 419 811 E

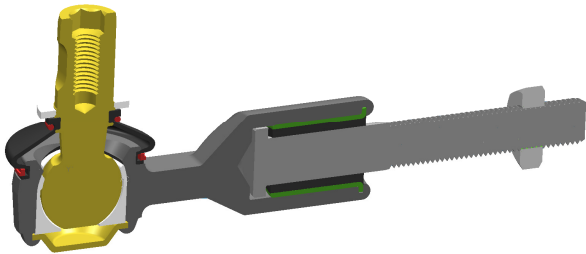
Original:

Problem:

- Play on Ball joint
- Silent block tears out
