Increased ballØ when surface pressure is to high

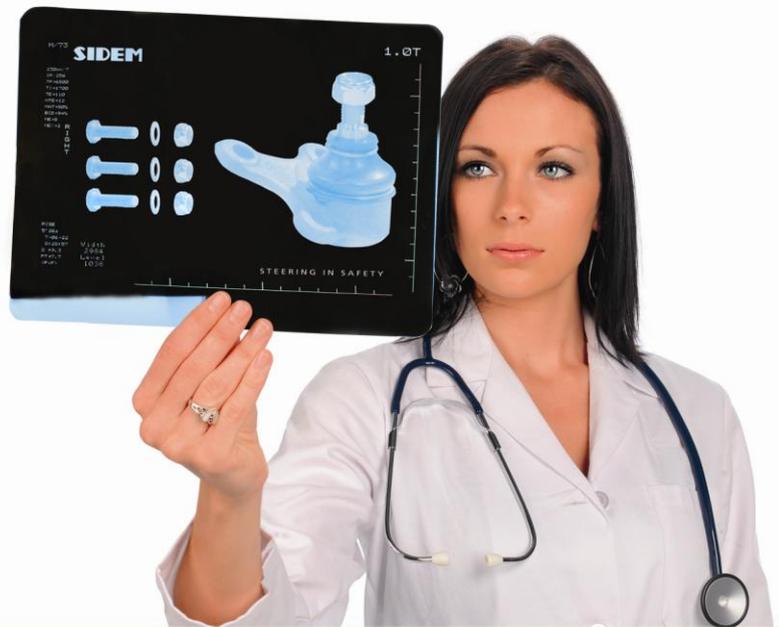
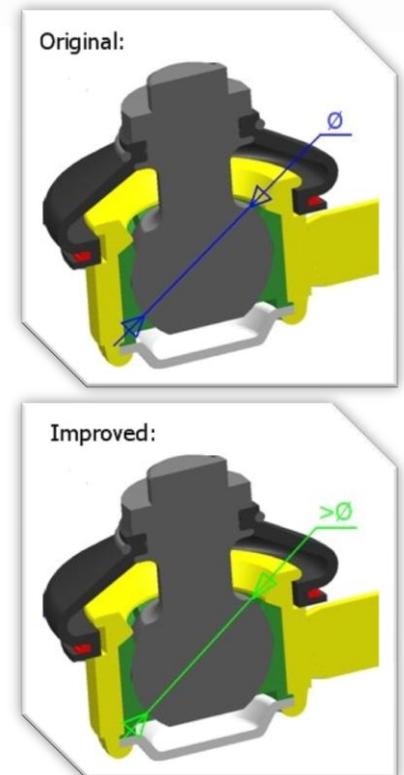
- Early play on OE Ball joints and Tie rod ends.

- The commercial vehicles who use these parts are big and heavy. Their weight, height, wind load ... cause high surface pressure on the ball head and makes them wear faster.

- If necessary we enlarge the ball pin diameter after extensive testing. This way we reduce surface pressure. This increases the overall stability and service life of these parts.
