Sidem Nr.	Application	Reference nr.
Stabiliser link	3360	Ford	1 361 653
		Seat	7M0 411 317 C
		Volkswagen	7M3 411 317 C

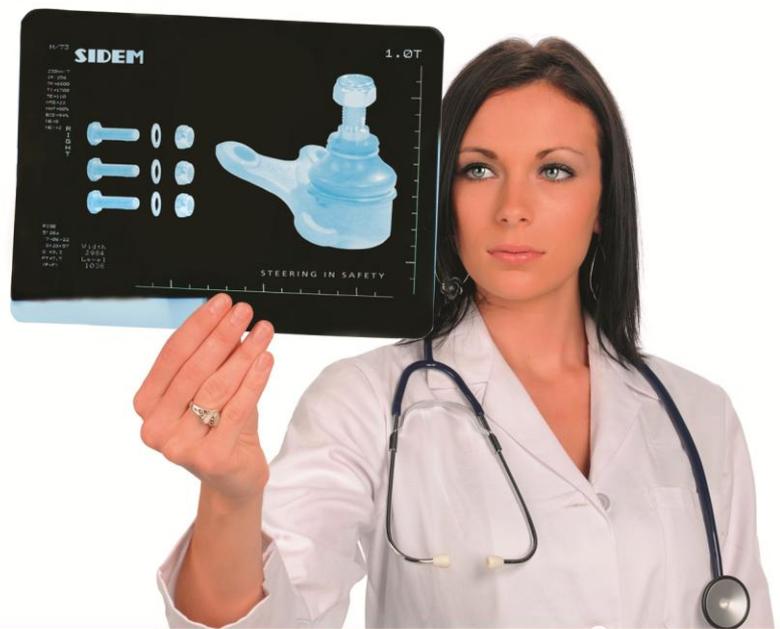
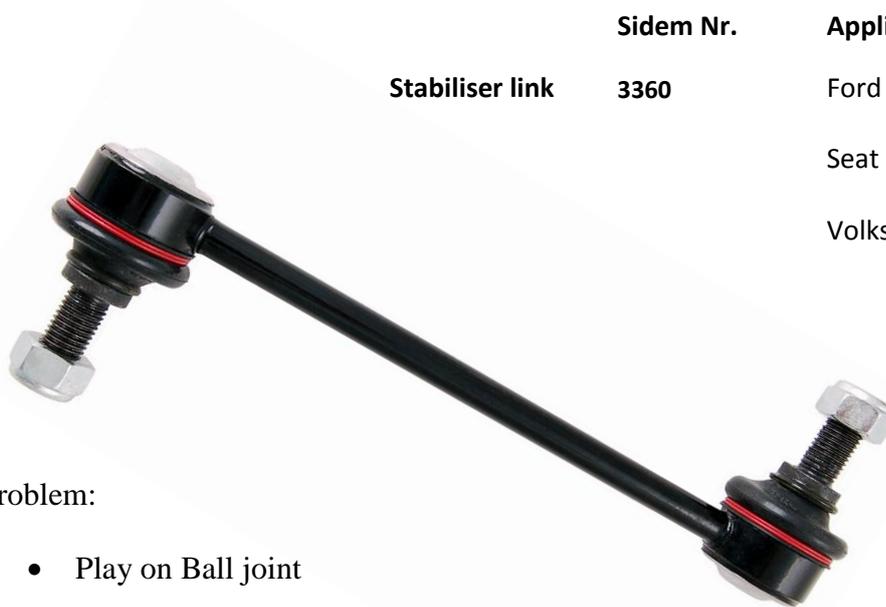
- Play on Ball joint

- Due to its location, this stabilizer link is exposed to all kind of external influences. When a dustcover is damaged or is not fitting perfectly, water and dirt finds its way into the joint. This causes oxidization of the ball pin, which leads to wear of the plastic cup.
- The cars who use this stabilizer link are big and heavy cars. Their weight, height, wind load ... cause high surface pressure on the ball head and makes them wear faster.

- Use dustcover which fits perfectly along the rod.
- Enlarge ball pin diameter of the joints to reduce surface pressure.
