**Track Control arm
BMW (E46)**

Sidem Nr.
21674 R
21675 R

Reference nr.
31 12 6 777 851 R
31 12 6 777 852 R

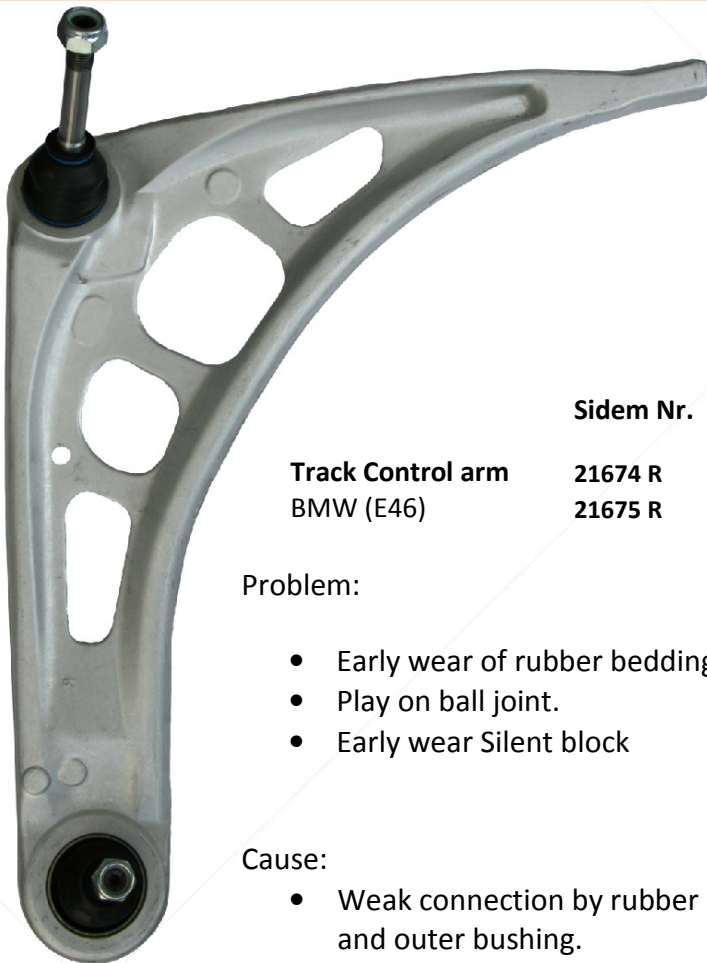
Problem:

- Early wear of rubber bedding Ball Joint.
- Play on ball joint.
- Early wear Silent block

Cause:

- Weak connection by rubber between inner and outer bushing.
- Damaged dustcover.
- Wrong method of mounting silent block.

! When the arm with rubber bedding is replaced by the improved version, replace both left and right arm !

Solution:

- A new ball joint is progressed without the rubber core.
- A cover is added to protect the pin and the dustcover during transport and storage.
- A document is added with mounting tips.
