Sidem Nr.	Reference nr.
Audi Tie rod end	37630	4F0 419 811 E

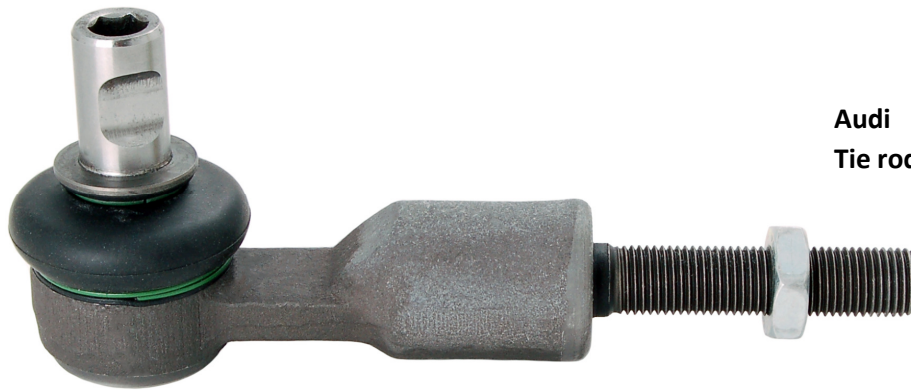
Original:

Problem:

- Play on Ball joint
- Silent block tears out

Solution:

- To prevent water-infiltration a new dustcover is designed with a perfect fit along the rod.
- A new rod is designed with an improved neck shape to ensure tight closing of the dustcover during movement.
- Extreme dynamic strain causes early damage of the metal rubber bonding, the design of the inner bushing is Modified to improve load capacity.
